CALIFORNIA DIVISION OF MINES AND GEOLOGY
FAULT EVALUATION REPORT FER-144

Pond Fault, Northern Kern County

Theodore C. Smith
Associate Geologist

April 12, 1983

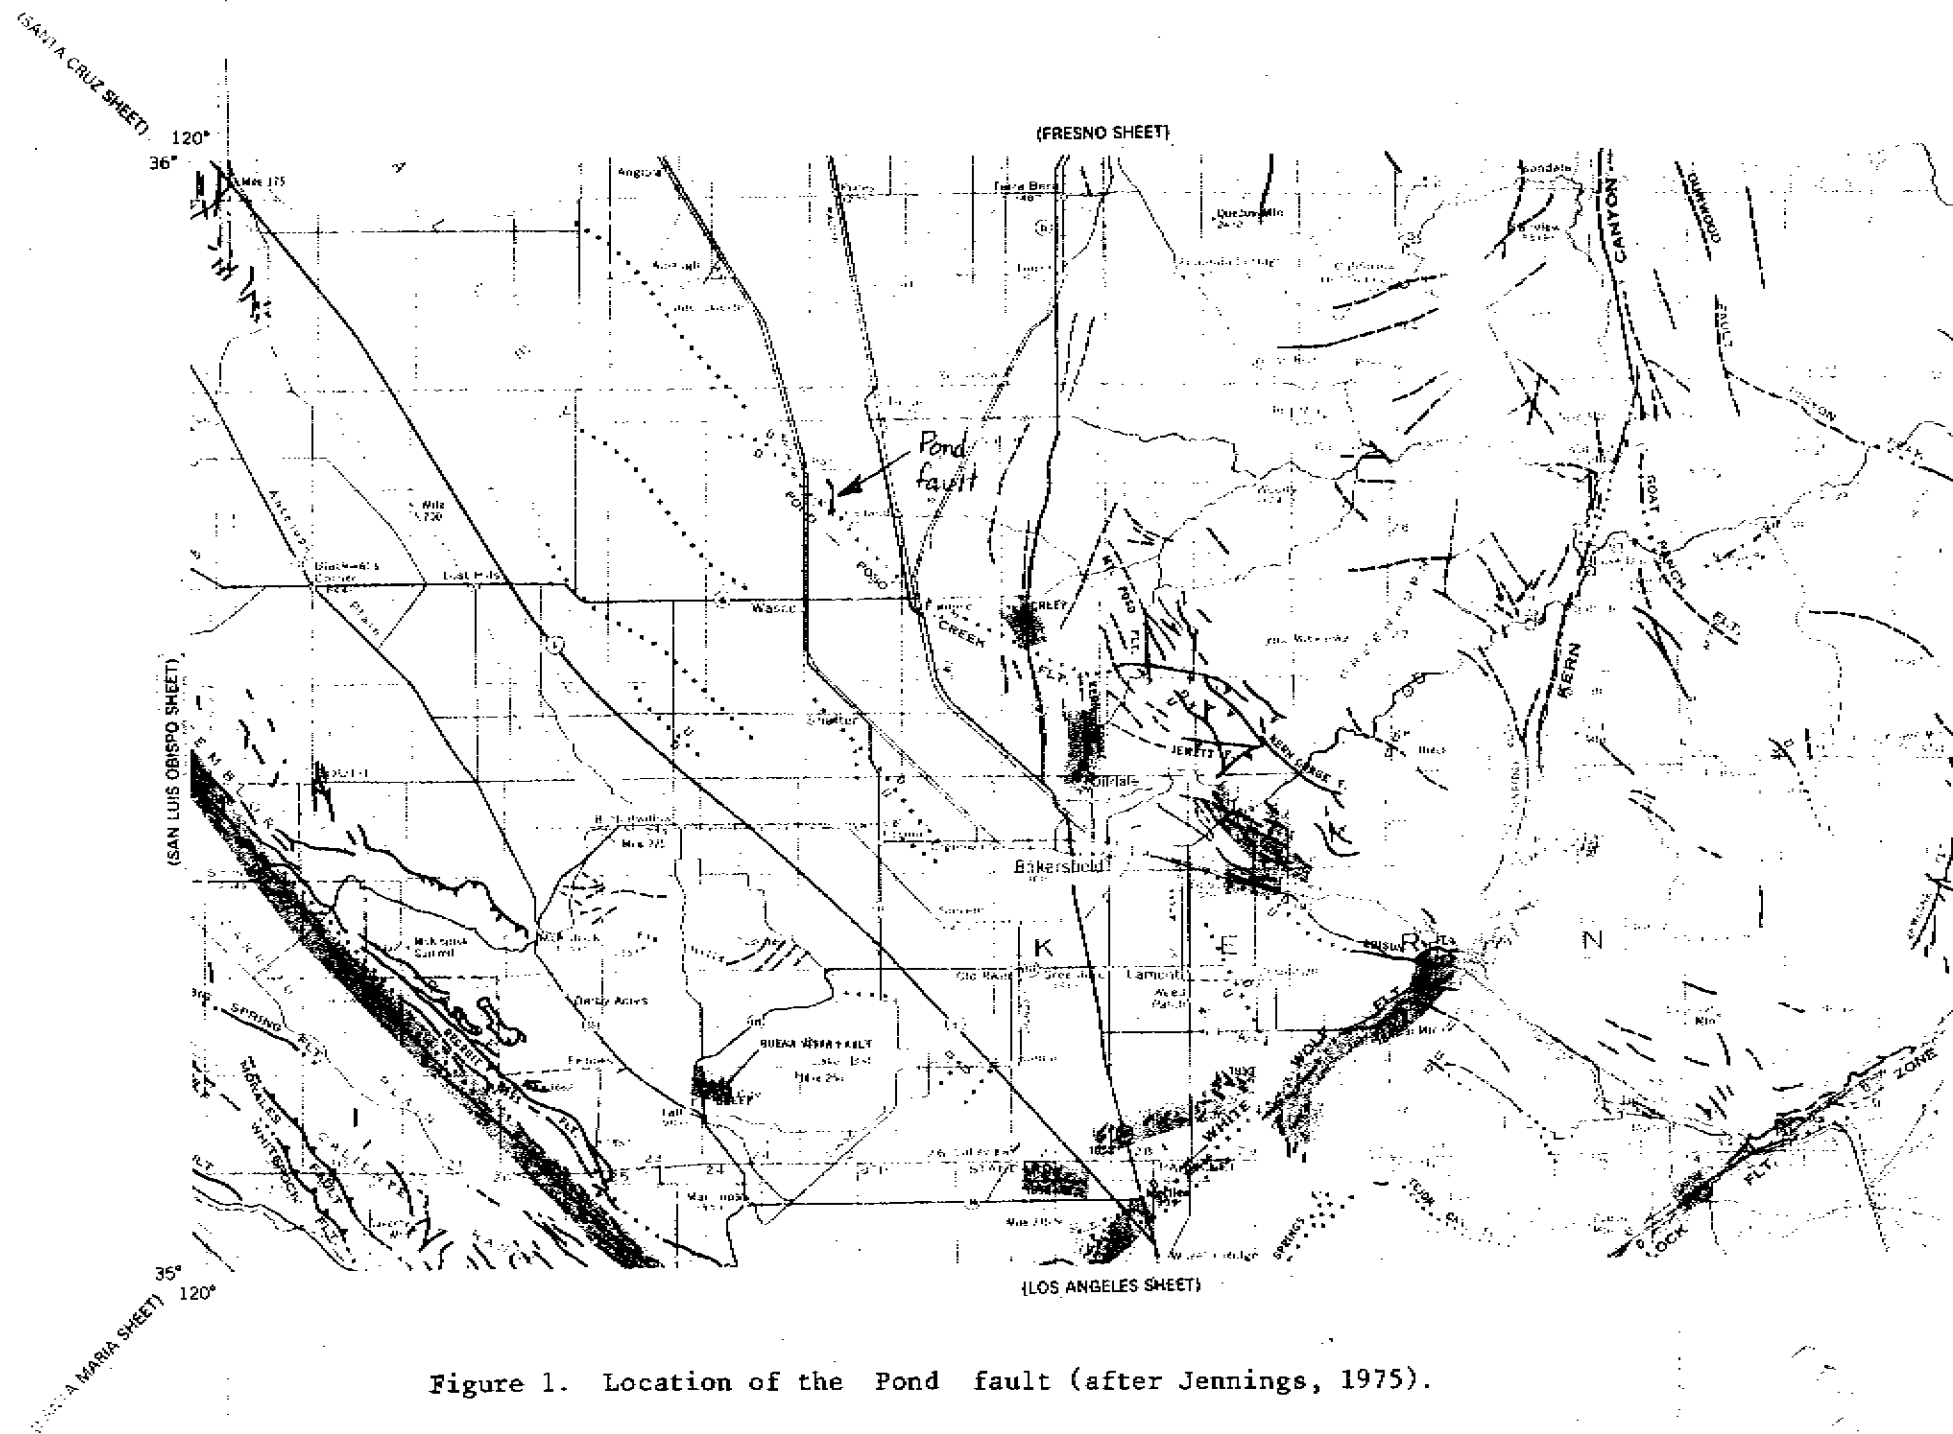
Figure 1. Location of the Pond fault (after Jennings, 1975).

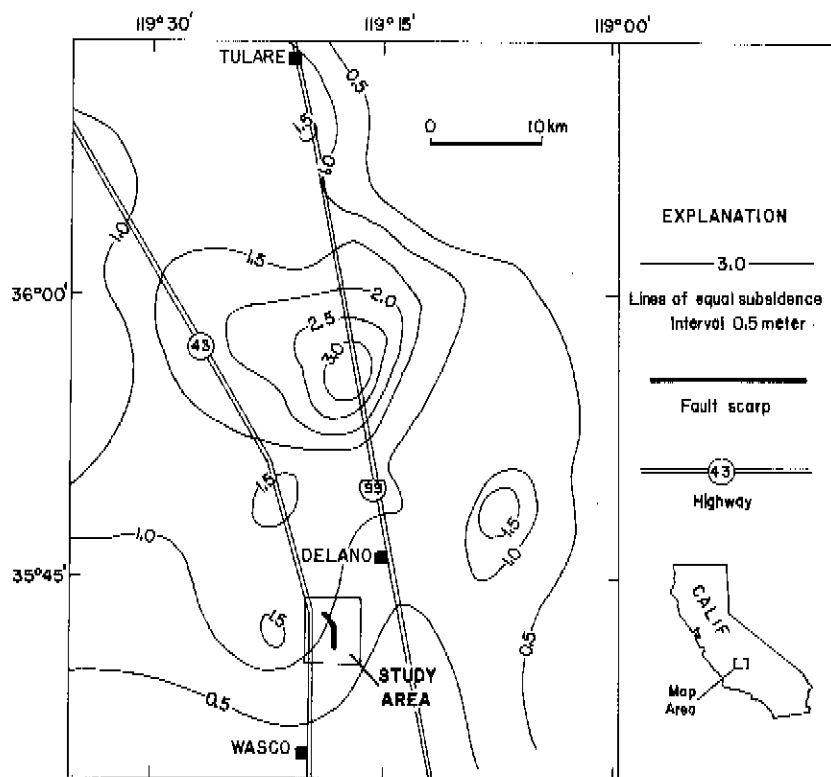
Fig. 1. Map of Tulare-Wasco, California, subsiding area, modern fault scarp formed by the Pond-Poso Creek fault, and study area. Land subsidence, 1948-1970, modified from Poland *et al.* [1975].

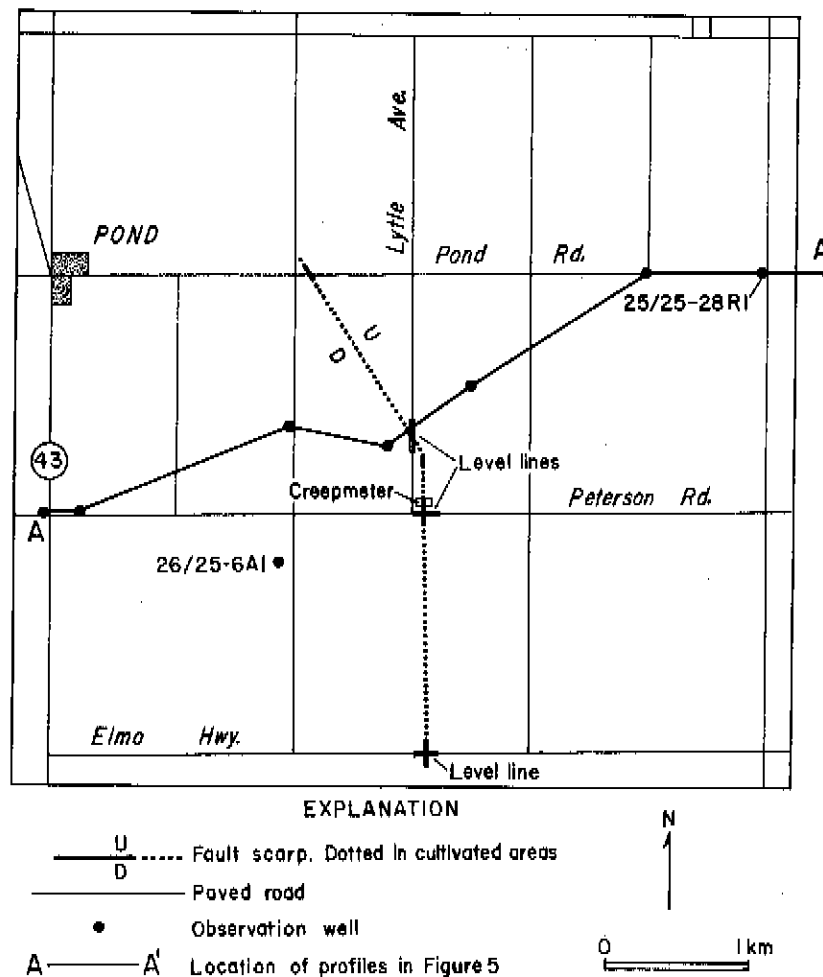
The modern surface faulting occurs on the northern part of the Pond-Poso Creek fault. Because the scarp formed by modern faulting (Figure 2) is continuously modified in cultivated areas between roads, the scarp is preserved only where it intersects paved roads and in a small uncultivated area immediately north of Peterson Road. Connection of these scarps suggests that a more than 3.4-km-long segment of the fault is active. Because the paved roads have been periodically regraded and resurfaced, total historic or modern offset of the land surface can be only estimated. An upper limit to historic offset as of 1974, however, was established by trenching of the fault between Elmo Highway and Peterson Road (Figure 2). At a depth of 3 m from the land surface, approximately 230 mm of vertical offset was observed [Los Angeles Department of

Fig. 2. Map of study area with modern fault scarp, fault monitoring sites, and wells referenced in text. See Figure 1 for location of study area.

Level lines to monitor fault movement were established in 1977 on three paved roads intersected by the modern fault scarp (Figure 2). Bench marks consisted of 64-mm-long P-K nails driven flush with the pavement along the center line of the roadways. Bench marks were spaced symmetrically about the surface scarp from 1.5 to 46 m from the scarp. All leveling before March 1978 was performed with a Jena Dahlta 010A theodolite and Philadelphia rod with a micrometer. Measurements were reproducible to 1 mm with this system. Leveling after February 1978 was performed with a Zeiss Ni-1 automatic level and invar survey rods, a system designed for precise geodetic leveling. In September 1977 a tiltbeam or creepmeter with a nominal sensitivity of 0.097 mm/m [Nason, 1971] was established across the fault 67 m north of Peterson Road (Figure 2). The creepmeter was read manually. Because the ends of the tiltbeam were 1.7 m apart, the tiltbeam presumably measured only vertical offset across the fault.
